ROYAL AIRCRAFT ESTABLISHMENT FARNBOROUGH (ENGLAND)
HOLOGRAPHIC INTERFEROMETRY OF CFRP WING TIPS. (U)

Technical Report 78105

HOLOGRAPHIC INTERFEROMETRY OF CFRP WING TIPS

M. Marchant

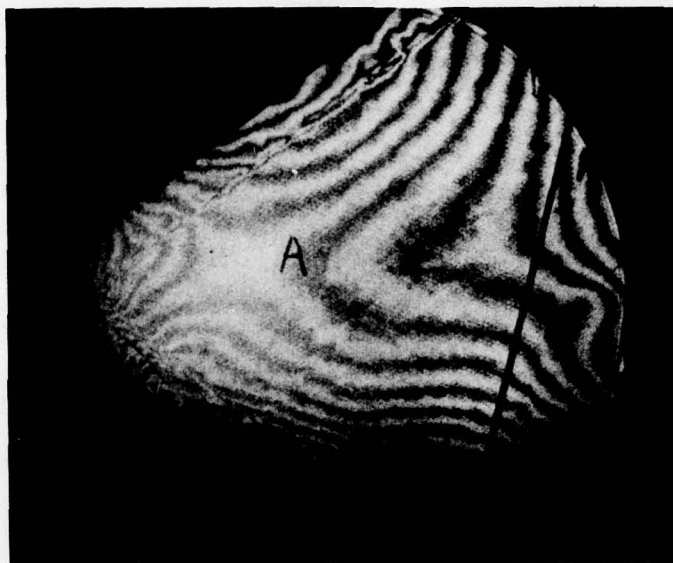
introduce misleading fringe patterns; the large distortion in the fringes on the right in Fig 3 corresponded to the position of such a point, and disappeared completely when the cords were readjusted. With a structure such as the wingtip, the patterns formed are naturally complicated, particularly around joints in the framework, which itself produces discontinuities. However, major faults should be distinguishable, since very similar basic patterns are recorded for each tip.

Fig 3 Distortion caused by strain in mounting

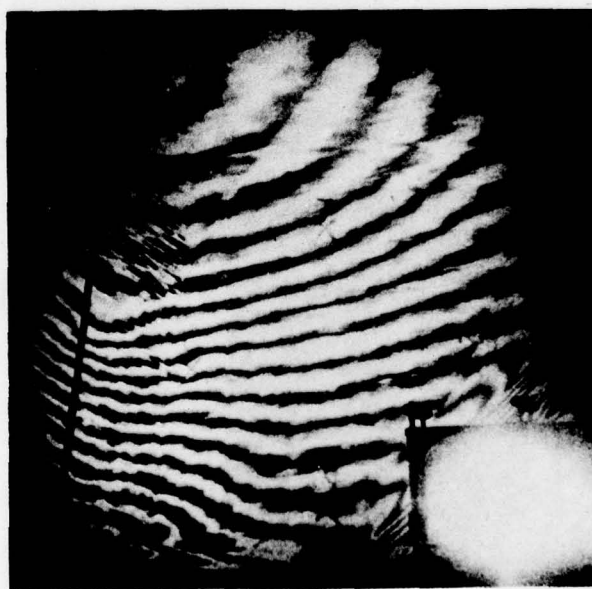
Fig 4 shows two prominent anomalies detected on the bottom surface of tip 6. These are, firstly, a part of the straight line seen on all but the first tip examined, and running horizontally in the photograph, and secondly an area of rather jagged fringes on the left, quite unlike any other area seen. It has been suggested that the latter might be caused by poor skin quality and the former by an overlap in the film adhesive. It was visible on both top and bottom surfaces in the same position on the wingtip, and was not revealed by radiography nor ultrasonic scan. A very minor discontinuity for which no explanation is available appears at 60° to the main line; the large pattern at bottom right behind the reference mirror corresponds to the internal framing.

Fig 4 Anomalies in wing tip 6

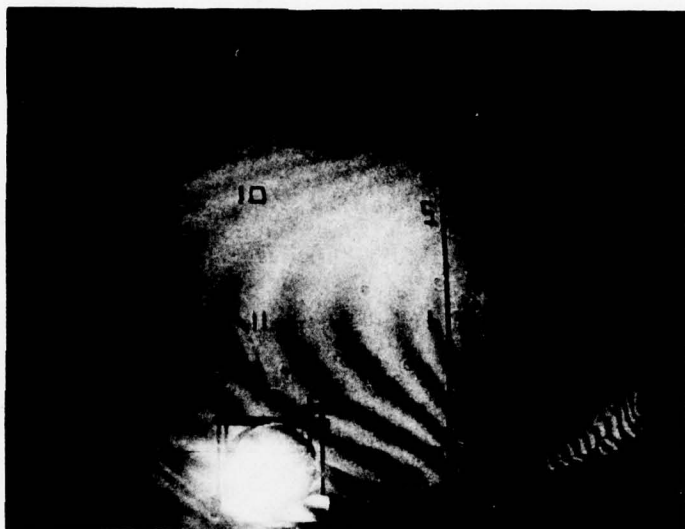
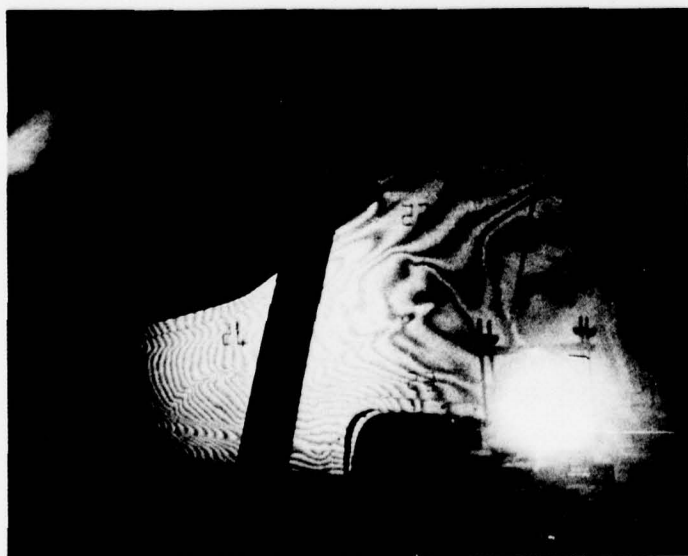
Fig 5a-c Wing tip 8 — top

Figs 5a-c show the results obtained on the top surface of tip 8. This tip was received direct from the manufacturers and had had no previous tests applied to it. Some very prominent anomalies were found in all areas as well as traces of a straight line (above '10' and '15') similar to that on tip 6. It seemed just possible that this line might be due to some strain in the mounting, although the earlier tests had involved relocation, so a series of photographs was taken with the support rollers lower relative to the 3-point mount and then with the tip tilted through approximately 12° in each direction.

a Area 1 — various anomalies

b Area 2 — various anomalies including line

c Area 3 — various anomalies

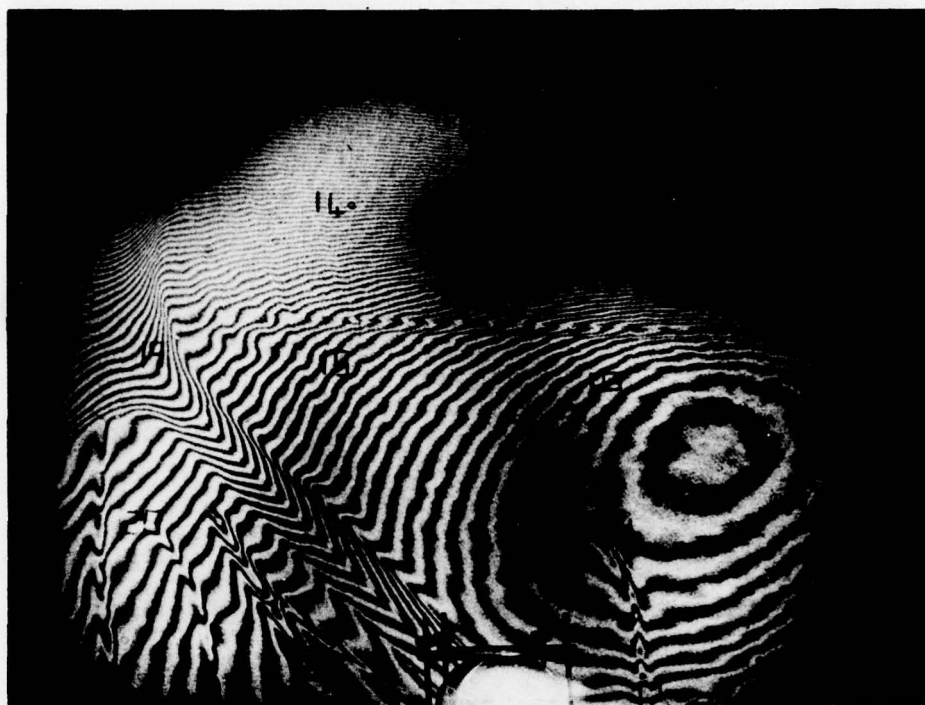
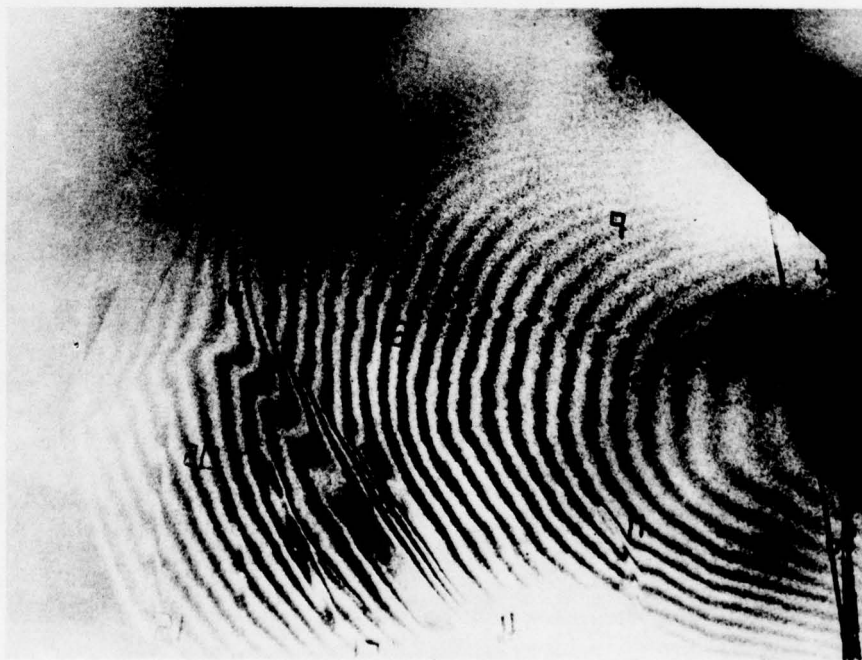
Fig 6a&b Check of line anomaly in two mounting positions

The typical results of Figs 6a&b show that, within the accuracy of observation the line remained fixed relative to the reference numbers in all cases.

a Level

b Tilted 12°

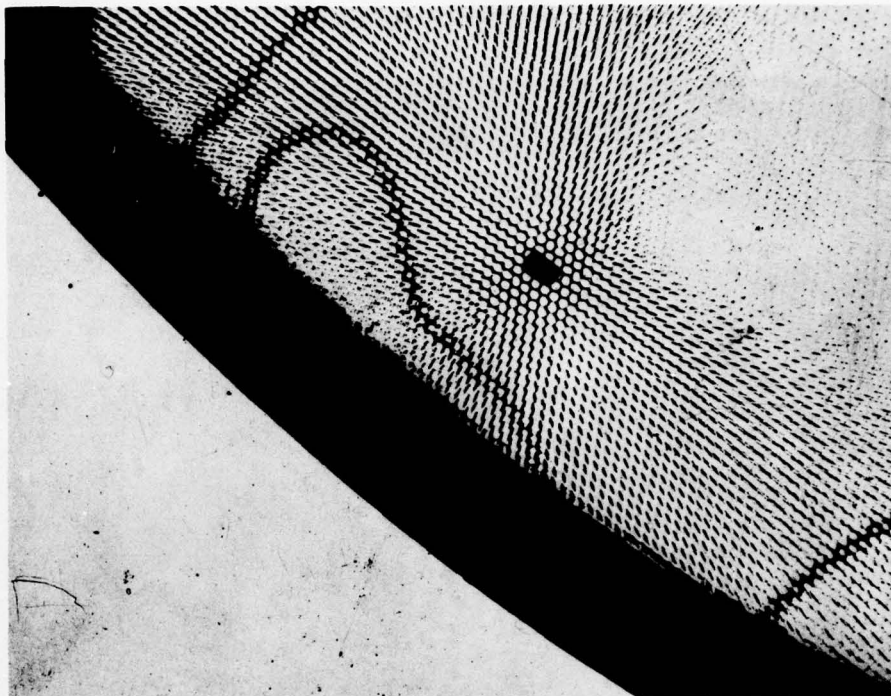
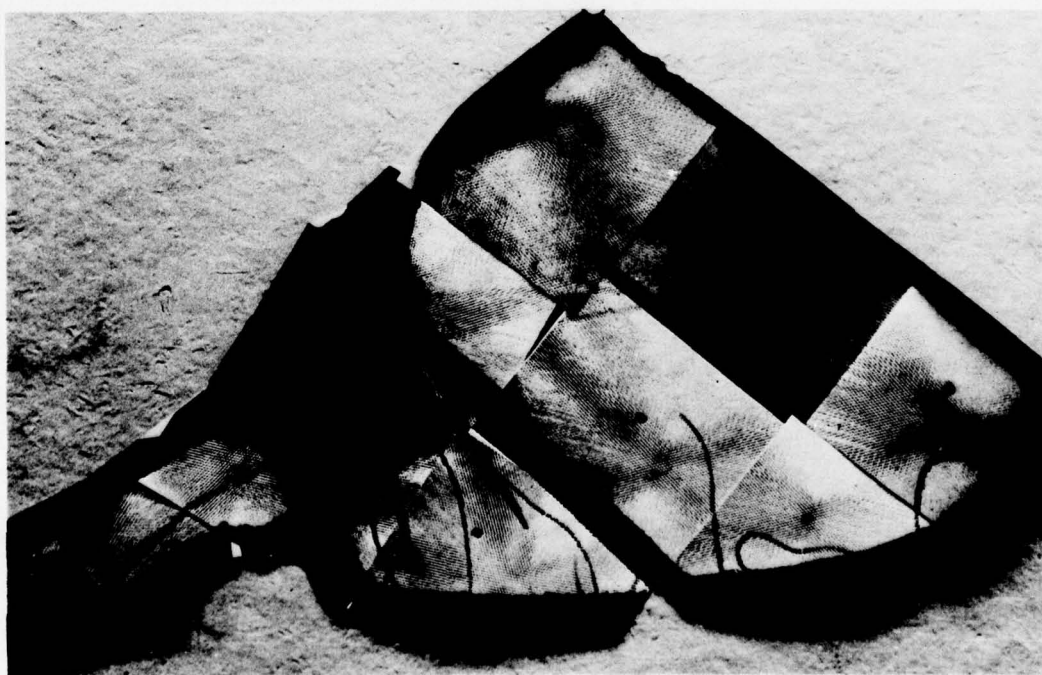
The wingtip was radiographed in an attempt to find the cause of these anomalies. A typical result is given in Fig 7a and a rough mosaic of the whole

tip in Fig 7b. Agreement with the holographic results is remarkably good. All the 'faults' shown in Fig 5 (and two others, thought to be nearer the bottom skin) can be seen with the exception of the straight line. These two 'faults' were detected holographically later (see Appendix).

a Radiograph of area near '12'

b Mosaic of radiographs of whole wing tip

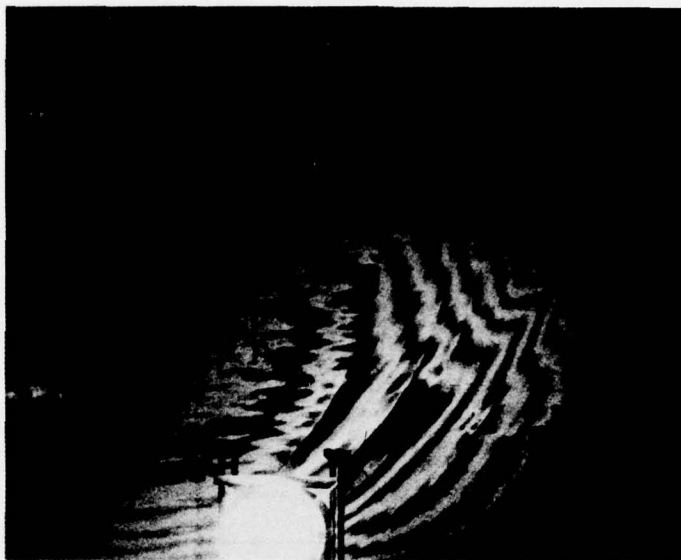
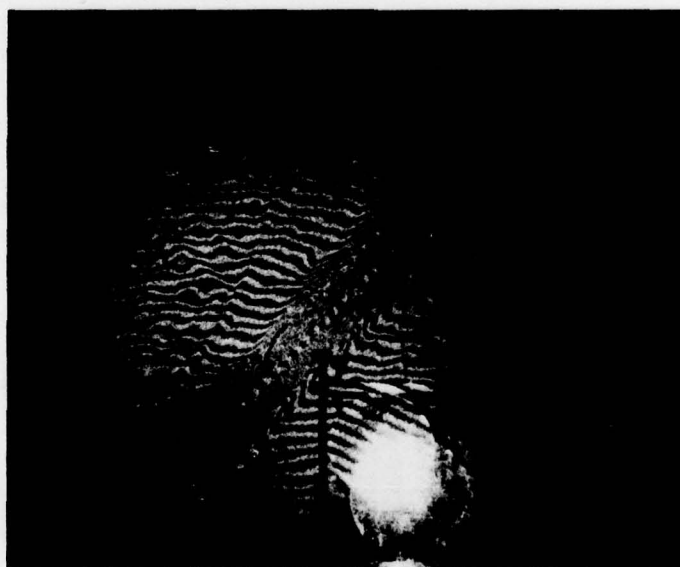
Fig 8a&b Wing tip 8 — bottom

The set-up for examining the bottom surface was extremely stable and it was noticed that after some hours more skin laminae could be seen (Fig 8a is an example) and that later still the fringes developed a very irregular appearance (eg Fig 8b).

a Area 5 — laminae prominent after 4 hours

b Area 6 — irregular fringes after 8 hours

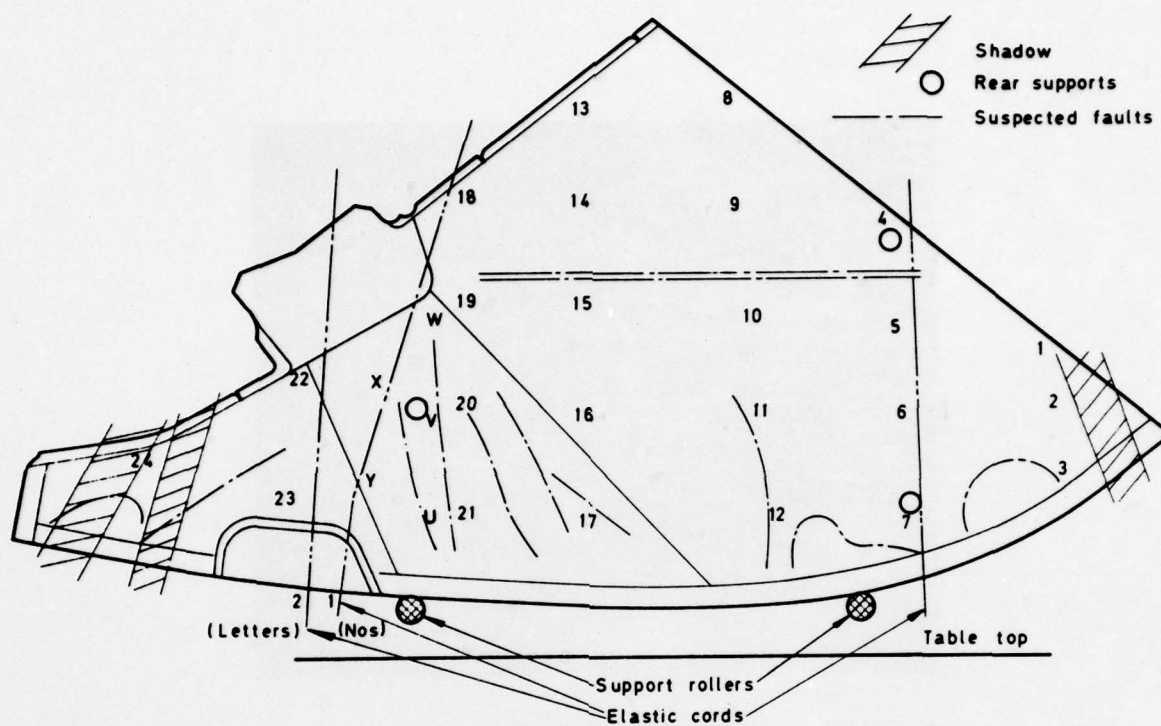
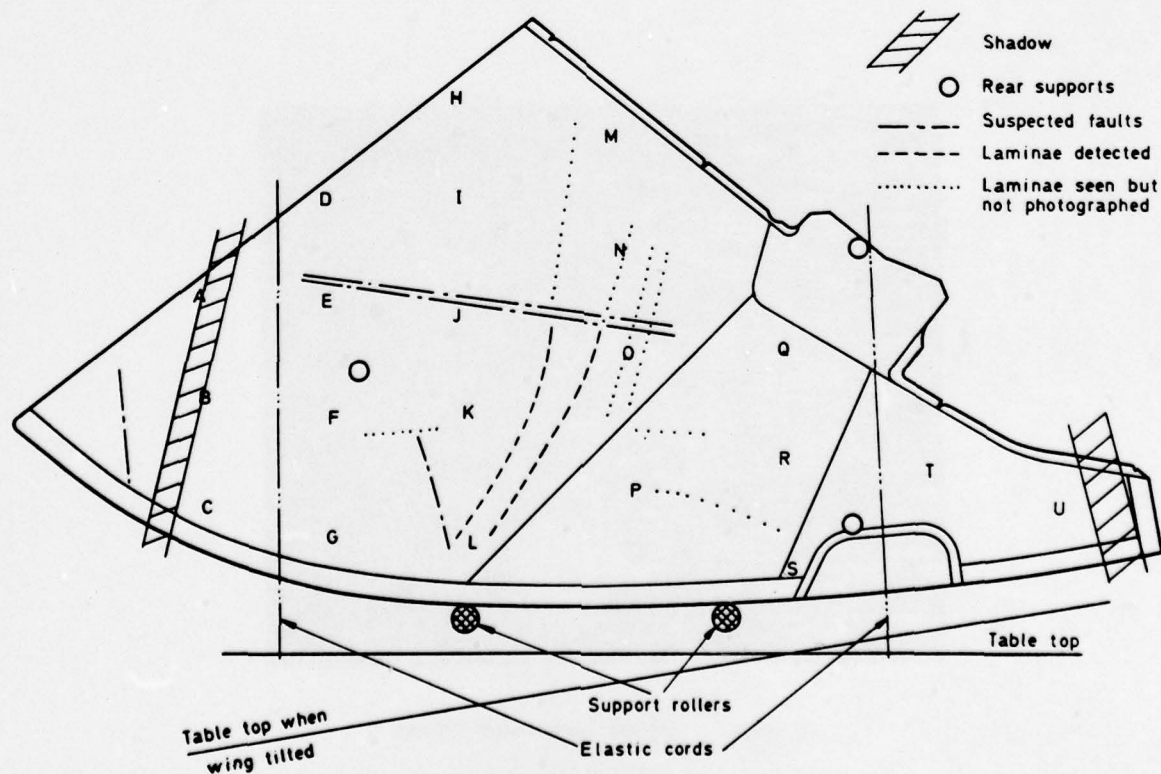
Fig 9a&b are sketches to show mountings, reference marks, and all anomalies seen. These include (9b) an indication of a number of laminae which were detected visually after prolonged heating of the front surface but were not photographed because of focus changes.

Fig 9a Wing tip 8 — top surface

Fig 9b Wing tip 8 — bottom surface

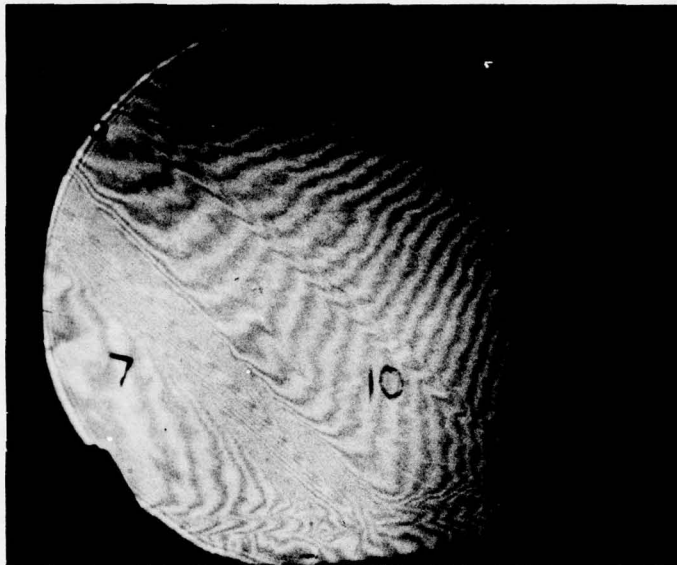
Tip 10 had undergone other tests before reaching us and cement patches remained on the bottom surface. The positions of three circular anomalies detected on the top surface (between '9' and '11' in Fig 10, for example) correspond to such cement patches underneath. There was no sign of a straight line in the position of those on tips 6 and 8, but a very similar effect can be seen running diagonally and roughly parallel to the internal rib. A similar line was seen on the bottom surface in approximately the same position on the wingtip; and also on both sides of tips 12, 13 and 14.

Fig 10 Anomaly corresponding to cement on rear surface

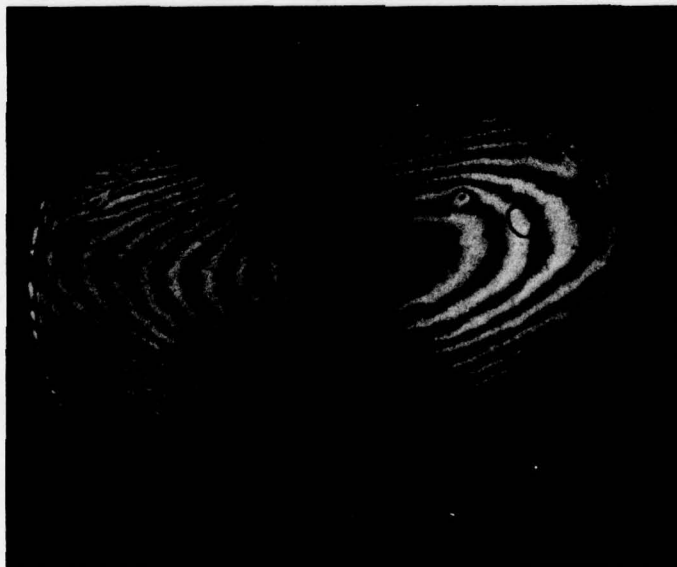
Patterns which may indicate debonding between skin and core were seen in a number of the photographs of various tips, and Fig 11 shows a typical one on the bottom surface of No 12.

Fig 11 Suspected debond

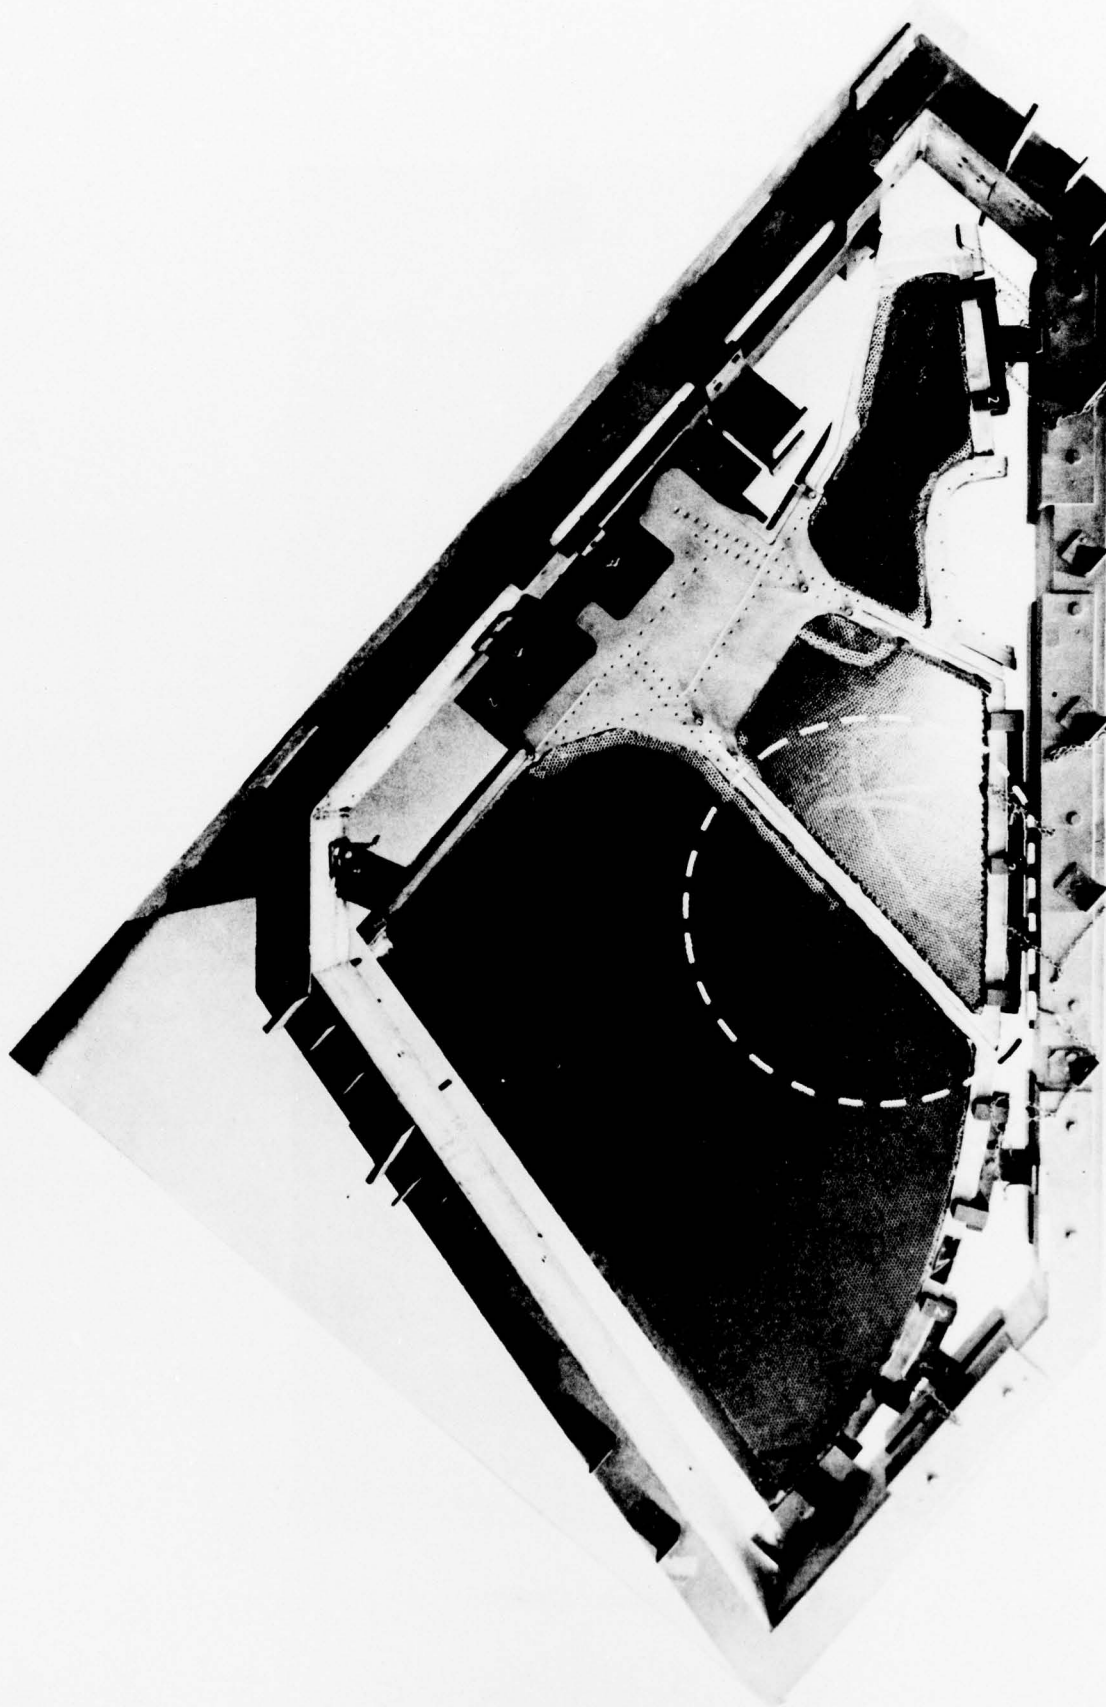
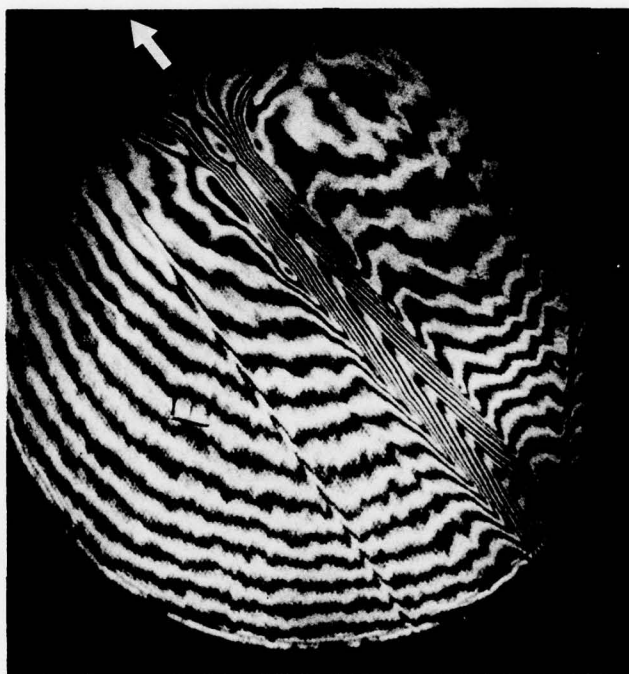
A photograph (Fig 12) supplied by HSA shows this tip before the skin was attached; a number of curved lines are clearly visible in the section between the ribs, but nothing was seen of these in the holographic examination (eg Fig 12). Radiographs showed no defects of any kind.

Fig 12a Wing tip 12 before skin attached

Fig 12b Patterns in area indicated by dashed circle

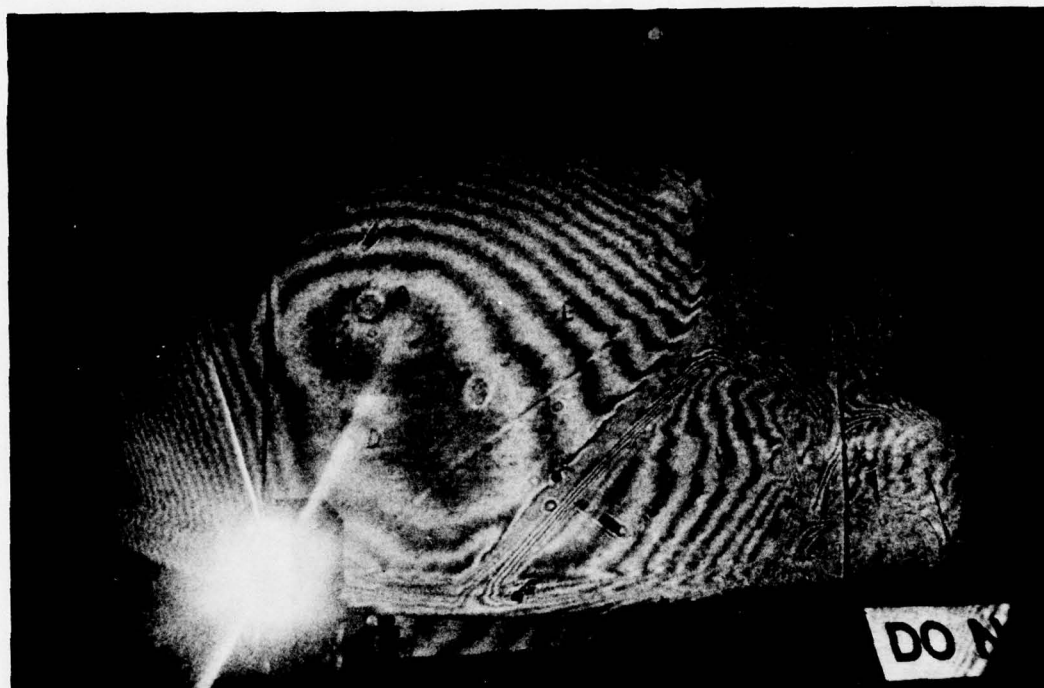
One surface of tip 10 was also examined using a much more divergent beam so that the whole area was illuminated at once. The result is shown in Fig 13; although the major anomalies can be seen, the quality is not good enough in this particular set-up to detect fine detail. In order to obtain sufficient divergence of the illumination, a negative lens had to be added and so the beam could not be spatially filtered; there are therefore spurious patterns caused by dust etc in the optical train as well as flare from the reference mirror which could not be placed outside the picture. These were, however, purely experimental problems and could be overcome with suitable equipment. It was also difficult to avoid

Fig 13 Whole surface illuminated

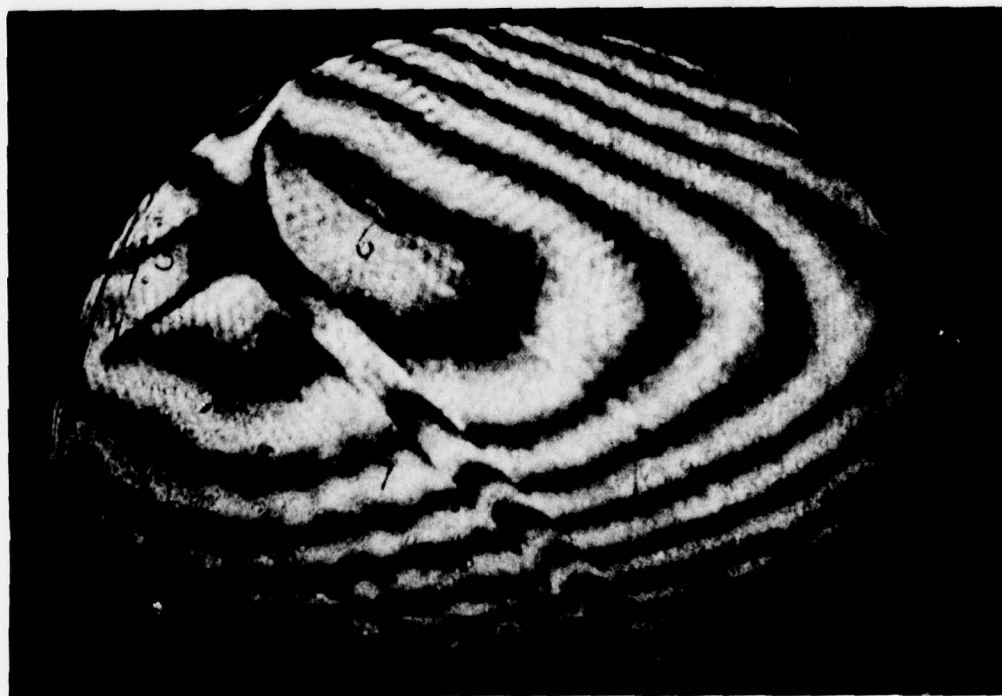
Double-exposure holograms were made of tips 8 and 10 using a pulsed ruby laser giving an exposure time of 30 ns with the tips simply set up on a wooden bench with a box as support. After recording the first hologram, heat was applied for a minute or so and the surface then allowed to cool a little before making the second exposure, the total time between exposures being approximately three minutes. A typical result is shown in Fig 14, which may be compared with Fig A11c.

Fig 14 Double pulse photograph

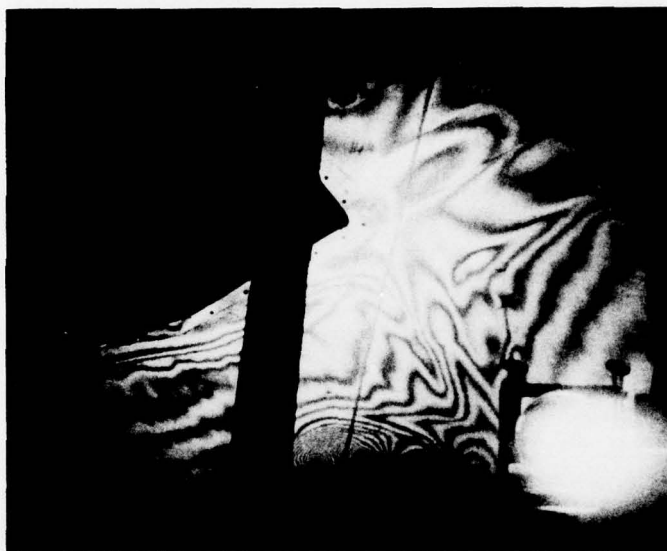
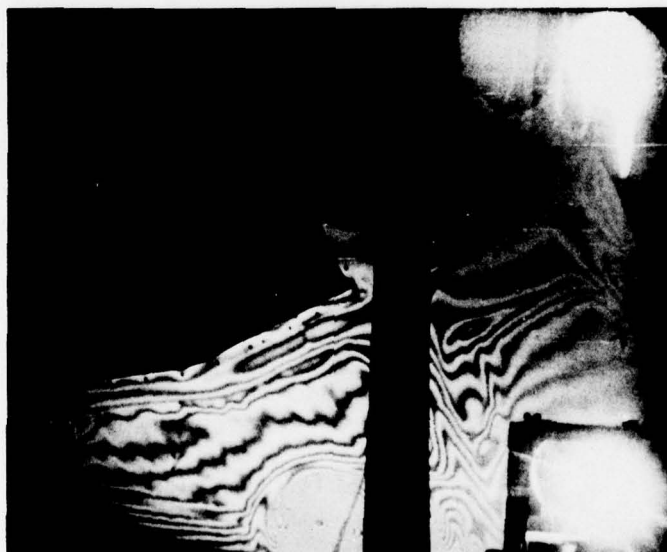
Fig A5d&e

- Fig A3 Diagonal line left of '1'
 Lines at centre left and top right of shadow.
 Possible debond between '8' and cement patch.
- Fig A5 Long horizontal line between '8' and '7' (second run).
 Possible debond below '9' (first run).
 Note: (d) and (e) are from different mounting positions and the shadow obscures different areas.

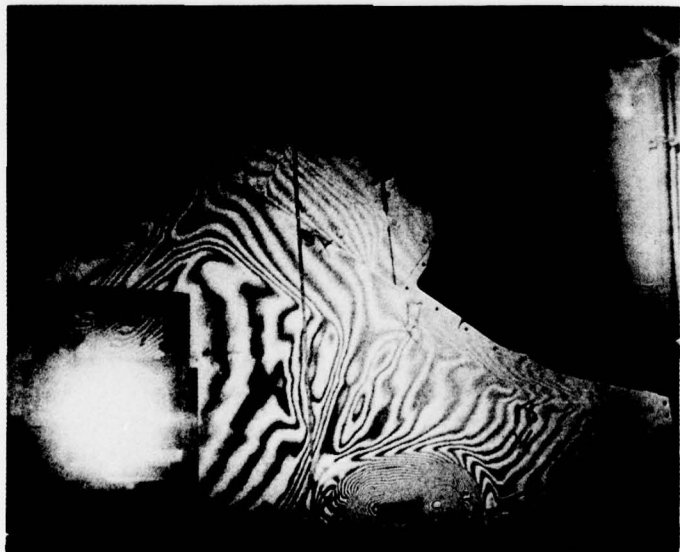
Fig A6d&e

- Fig A6 Long horizontal line below '3' and '8'.
 Rough area near '2'.
 Fine diagonal line left of '6' and '7'.
 Note: the large discontinuity between '6' and '2' corresponds to a rear support.

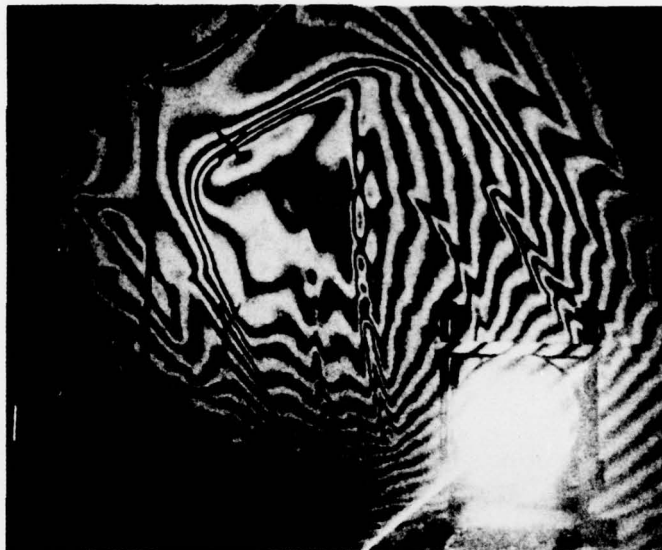
f Detection of
remaining fault
(see main report)

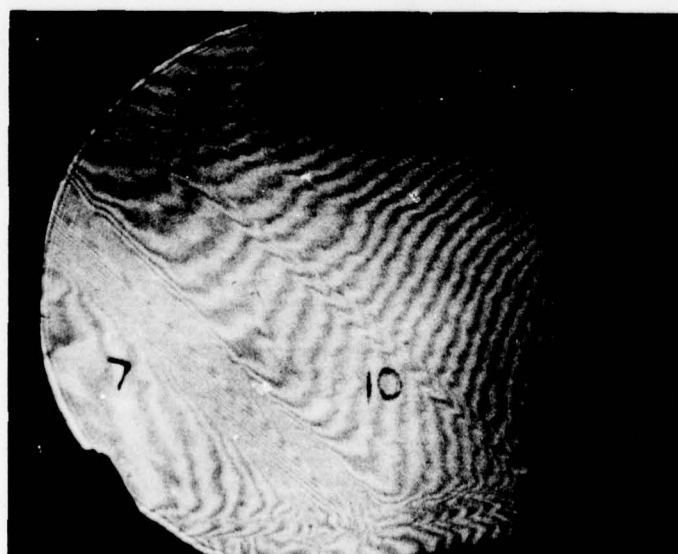
c

- Fig A11 Line through '6' and '10'.
 Possible debonds left of '8', right of '9' and right of '14'. See also main report.
 Faint line between frame and '10'.

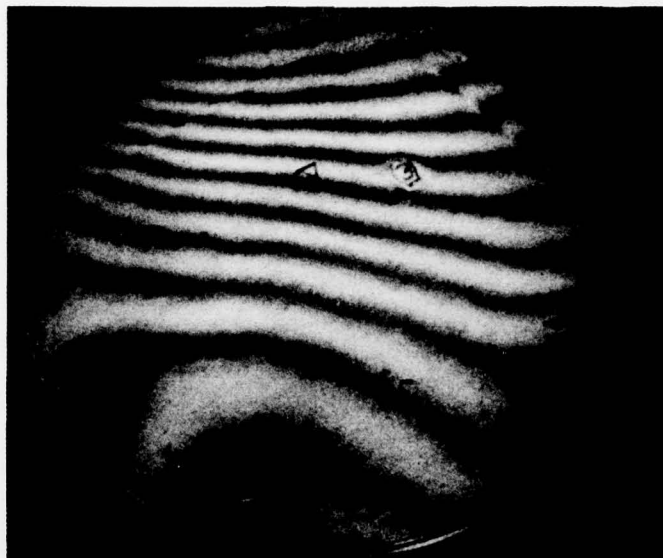
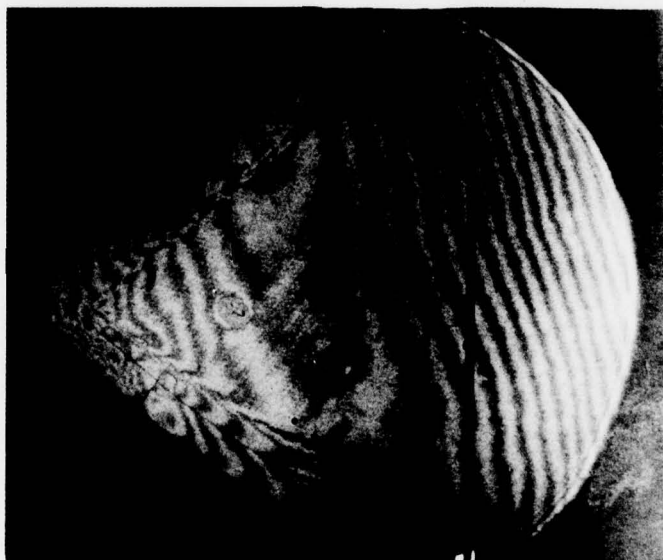
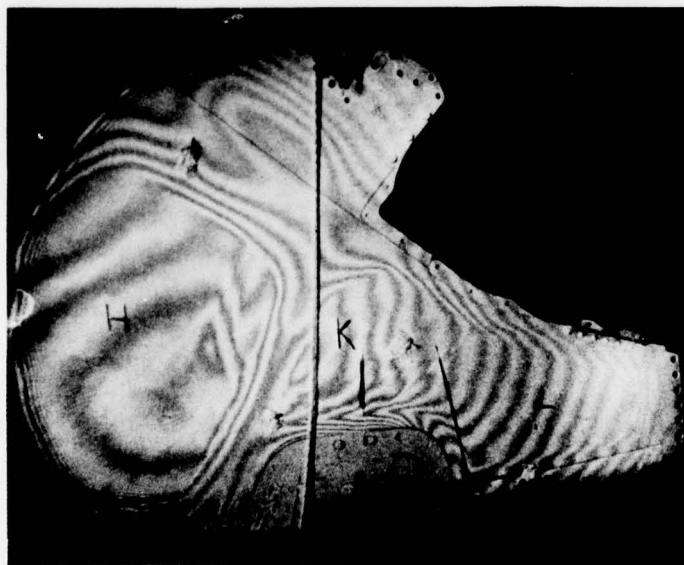
- Fig A12 Vertical faint line left of 'B' and 'D'.
 Various small circles left of this line.
 Line parallel to frame left of 'F' and 'G'.
 Faint diagonal line between 'K' and 'L'.

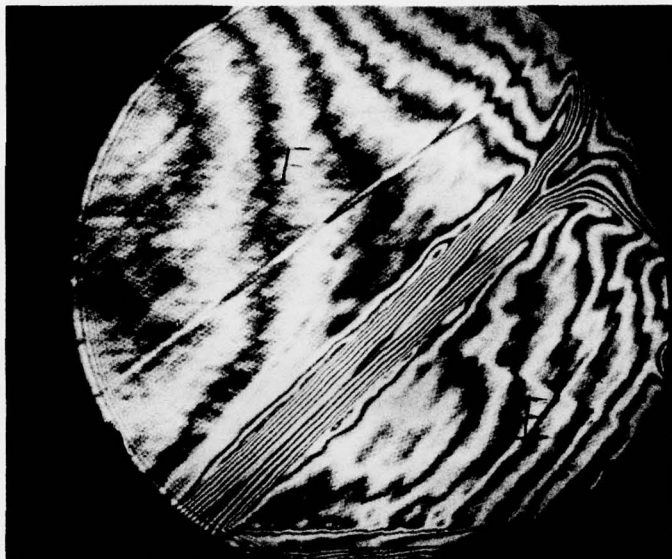
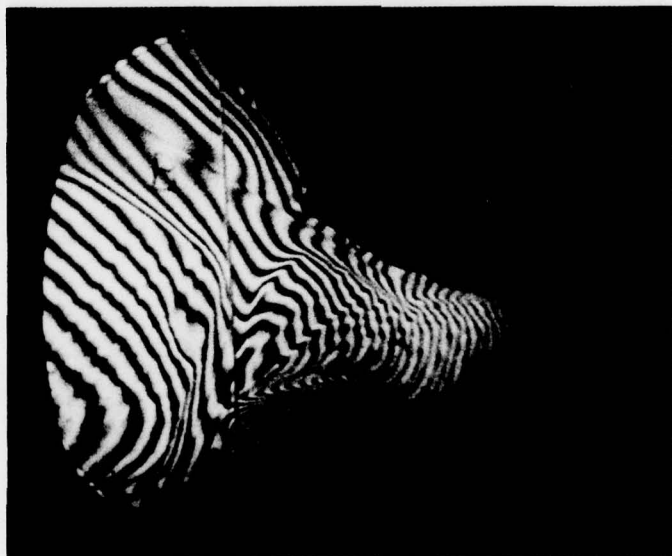
Fig A15d & e

- Fig A15 Line right of 'F' and left of 'H'.
Diagonal lines left and below 'J'.
Diagonal line left of 'K'.
Diagonal line left of 'A'.
Possible debond near 'C'.
- Fig A17 Line left of '6' and right of '7'.
Diagonal lines between '1' and '2'.
Note: photograph (f) was taken an hour later than (e), using fringe control to show detail left of '1' not seen earlier.
- Fig A18 Line right of 'F' and left of 'J'.
Horizontal line below 'C' and 'G'.
Diagonal line left of 'L'.
Vertical line right of 'B' and left of 'E'.
Note: large pattern between 'A' and 'F' corresponds to rear support.
- Fig A20 Line left of 'D', 'E' and 'F'.
Fainter line between rib and this line.
Diagonal line right of 'C'.
Diagonal lines between 'J' and 'K'.
- Fig A21 Line right of 'D', 'E' and 'F'.
Diagonal line left of 'A'.
Complicated pattern on metal edge near 'A'.
Diagonal lines left of 'L'.
